**ENVIRONMENTAL TEST
SONY DIR-1000, ID-1 DIGITAL TAPE RECORDER
(VIBRATION, TEMPERATURE AND HUMIDITY)**

John Morgan and Paul Beer
Mission and Avionics Technology Department (Code 5053)
NAVAL AIR WARFARE CENTER — AIRCRAFT DIVISION
Warminster, PA 18974-5000

13 MARCH 1992

FINAL REPORT
Period Covering 20 January 1992 to 24 January 1992

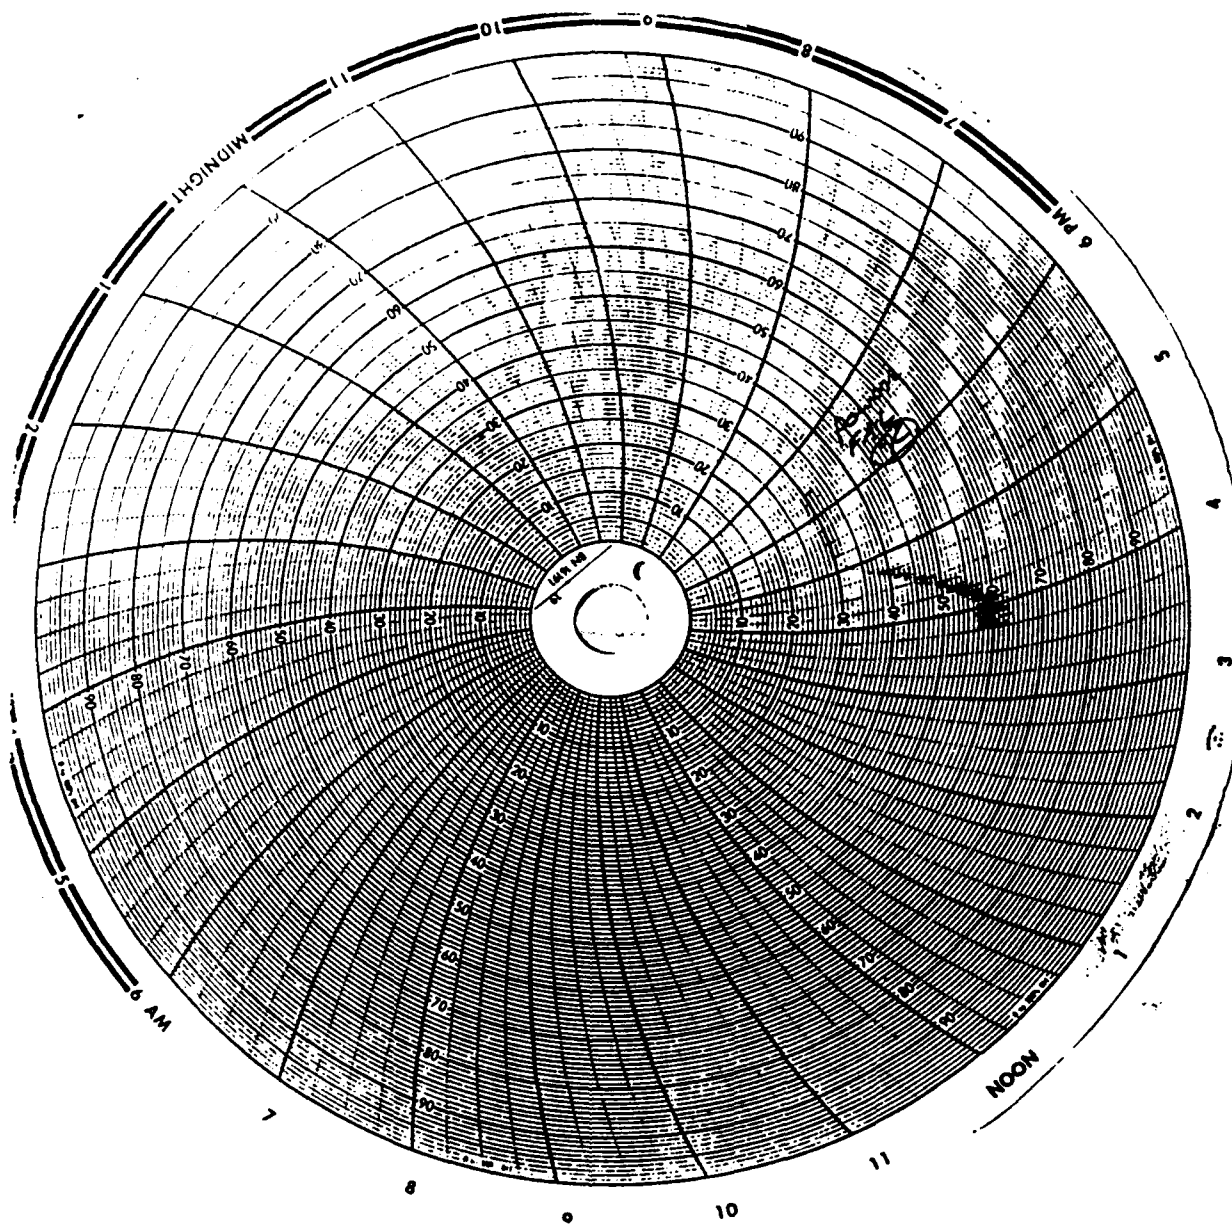
Figure C-4. Preliminary Data Only.
 Data: 23 January 1992 — 1545 Hours
 23 January 1992 — 1925 Hours
 % RH

The Unit failed subsequent to a 50C/122F, 60 % Relative Humidity soak, but this failure was not deemed "serious", in that it appeared to be caused by either a circuit board becoming unseated, or a Head clog, as the tape remained in contact around the Scanner even when not moving; see Appendix D for more detail.
